Selected AMLU Abandoned Mine Remediation Projects (2008-2009)

Cupolas Installed on Mine Shafts, BLM, San Bernardino County, February 2009

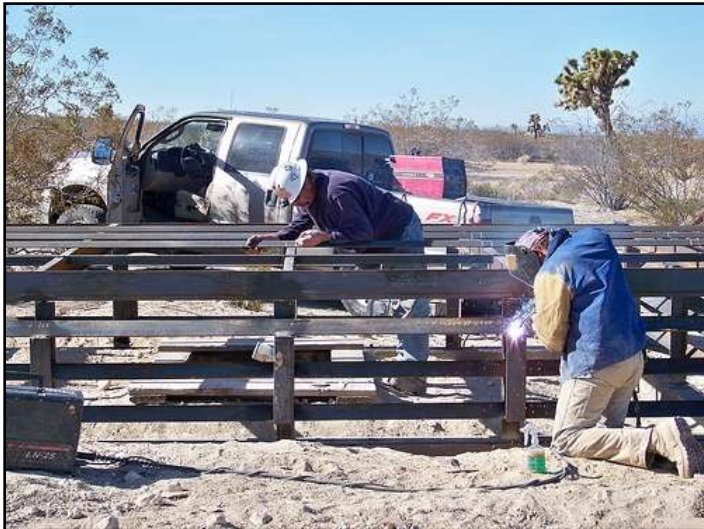
In January and February 2009, the AMLU partnered with the Barstow Field Office of the Bureau of Land Management (BLM) to install four cupolas and a grate on abandoned mine shafts near the city of Barstow, CA. These hazardous shafts are located in an area with lots of public visitation. Bat compatible closures were installed to preserve habitat while protecting the public from these hazardous features.

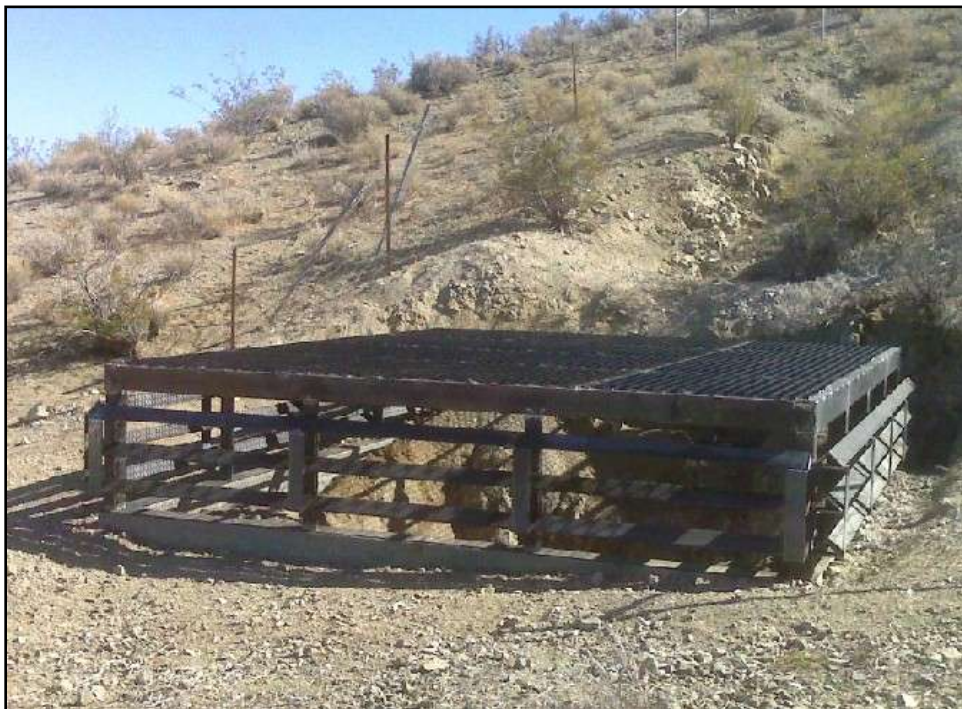
In late October 2008, AMLU completed its 500th physical hazard remediation project since 2002: the installation of a dome-like cupola to keep people safe while allowing bats to enter and leave at the Gold Bug Mine complex in Kern County. The project involved closing a 40-foot-deep shaft on U.S. Bureau of Land Management (BLM) property near Ridgecrest, less than a mile from Cerro Coso Community College. There's high traffic in this area, with people 4-wheeling, running, and walking their dogs in the Rademacher hills.

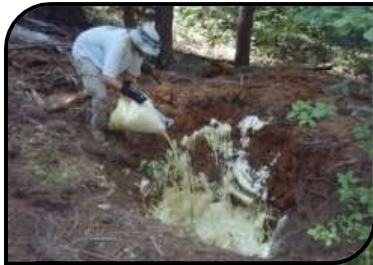
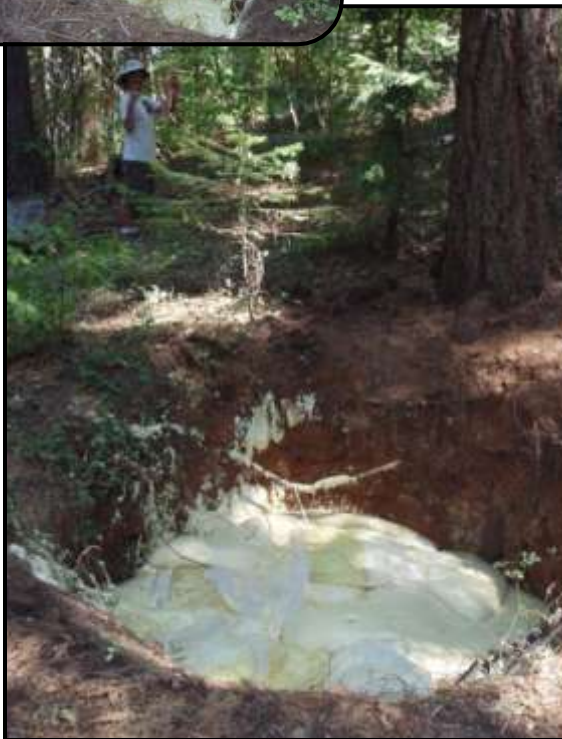
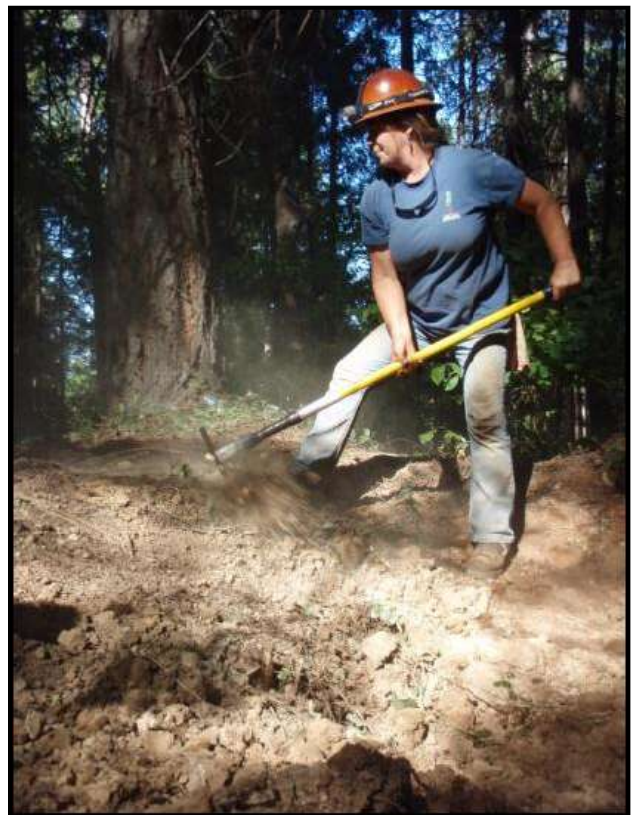
Shafts Plugged with Polyurethane Foam and Culverts Gate Installed, Eldorado National Forest, El Dorado County, August 2008

In August 2008, the AMLU partnered with the Eldorado National Forest to plug four shafts and install one culvert gate near the town of Volcanoville, CA. Polyurethane foam was used to seal the shafts located adjacent to a local horse trail after wildlife exclusions had been performed. It was also used to secure the culvert gate in place before being covered by several feet of dirt.

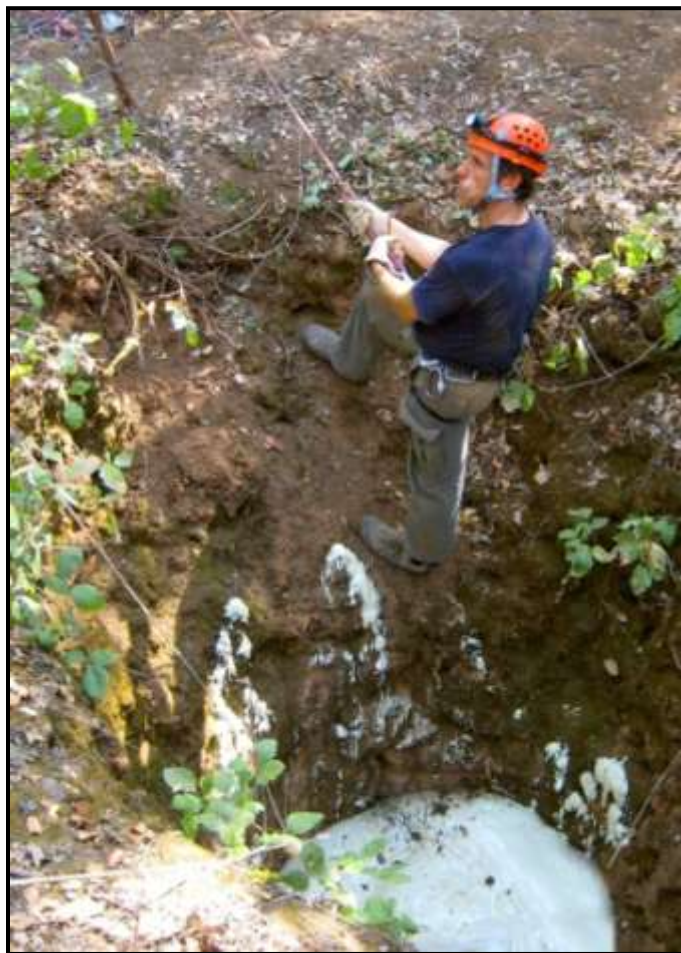
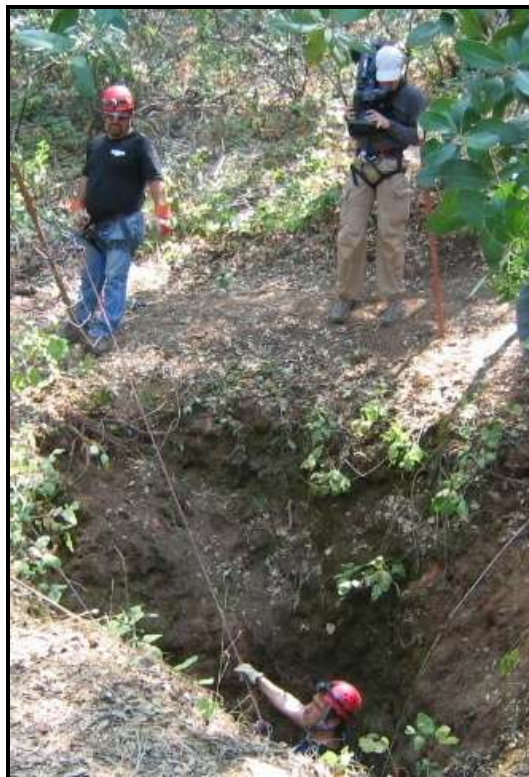
***Dirty Jobs* Filming of Shaft Plugged with Polyurethane Foam, Auburn State Recreation Area, Placer County, July 2008**

In July 2008, the host of *Dirty Jobs*, Mike Rowe, joined Ed Winchester, a Mine Safety and Health Administration-certified contractor who has worked with the Abandoned Mine Lands Unit (AMLU) on numerous abandoned mine remediation projects throughout California, to seal a dangerous abandoned mine shaft in the Auburn State Recreation Area in Placer County and to highlight the hazards associated with abandoned mines. Polyurethane foam used to close the shaft was donated by Dennis Dunham, president of Foam Concepts, a company based in Minnesota. The show (Episode #324, entitled “Abandoned Mine Plugger”) first aired on the Discovery Channel in January 2009.

The 50-foot deep shaft was located across the shallow and narrow Shirland canal from a well-used trail within the Auburn city limits and near to some relatively new housing developments. It was discovered only after a dog survived a fall down a slightly shallower shaft nearby, prompting a site survey. Staffs from the AMLU, U.S. Bureau of Reclamation, and California State Parks coordinated on site selection, environmental review, and project completion.

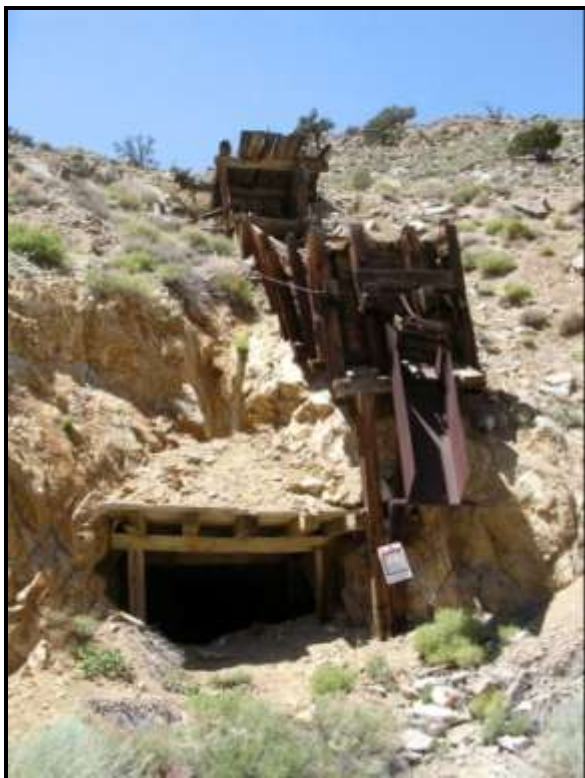
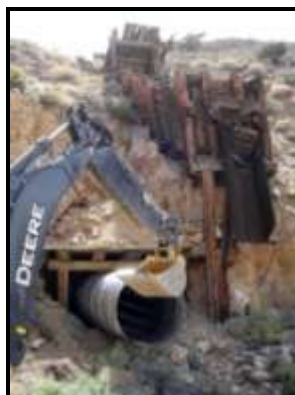
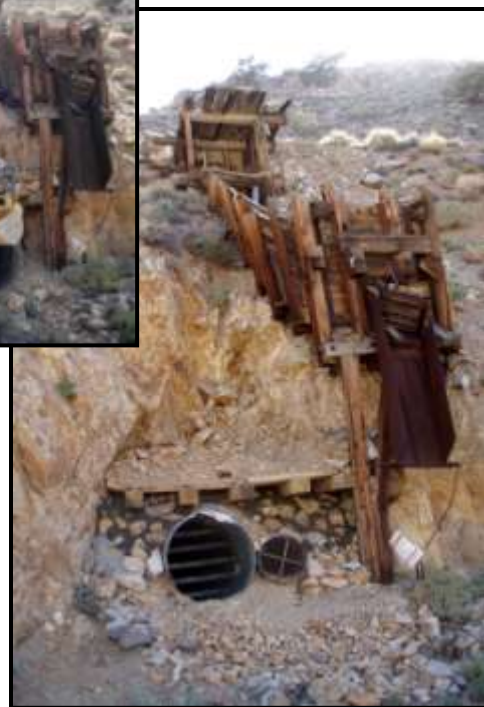
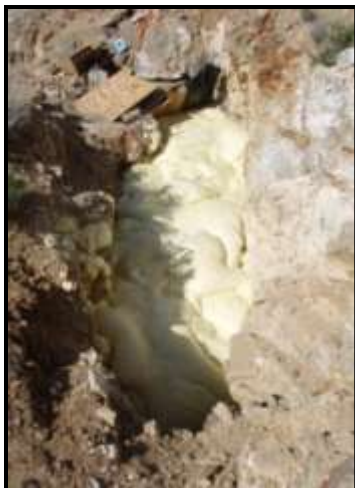
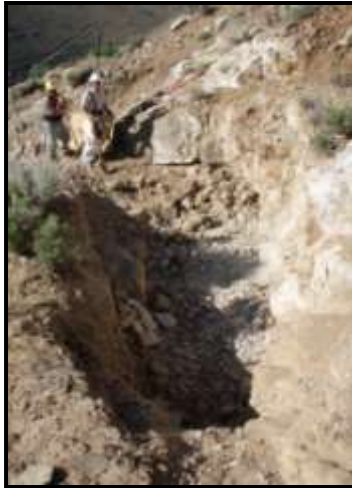
Culvert Gates and Fence Installed, Inyo National Forest, Inyo County, May 2008

In May 2008, the AMLU partnered with the Inyo National Forest (NF) to close four dangerous adits and fence a shaft near Independence, CA. Working together, they stabilized and secured the future of some of the unique historical mining structures at the site, abated physical hazards associated with these openings, and improved wildlife habitat. Inyo NF's road crew came out with a backhoe to help with the heavy lifting and backfill work, while the AMLU staff aided in the securing of two culvert gates and the placement of a polyurethane foam (PUF) plug. These were the last of several dangerous features to be remediated at this abandoned mine. In 2005 and 2006 the AMLU and Inyo NF partnered to close eight other features at the mine site.

"In 2008 OMR provided additional manpower to the U.S. Forest Service for closures of an abandoned tungsten mine located at the end of a popular OHV route near Independence, CA. Staff members from OMR assisted the U.S. Forest Service with the placement of culvert gates and foam on four adits."

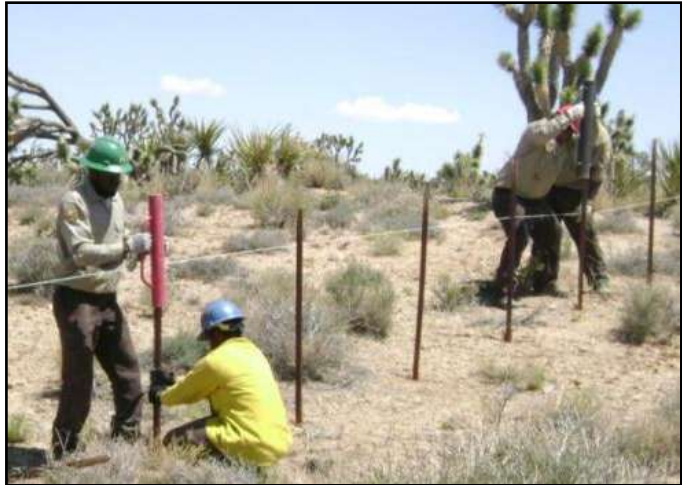
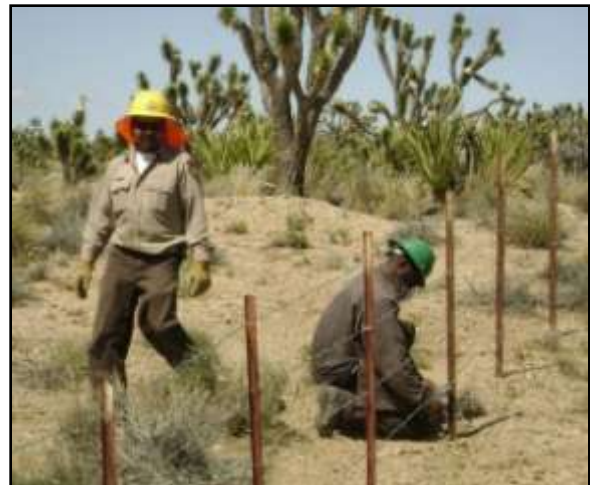
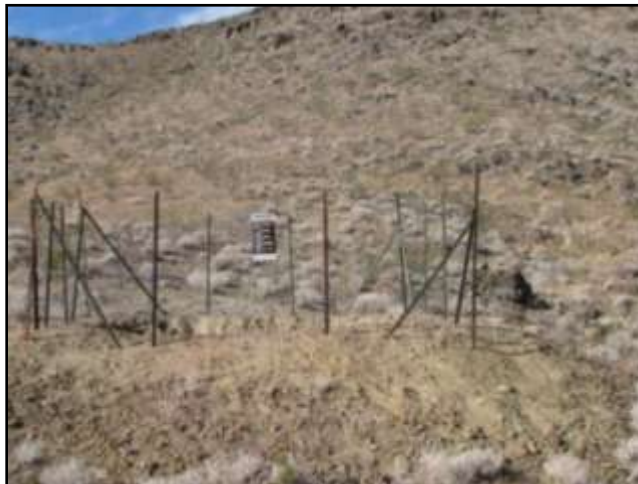
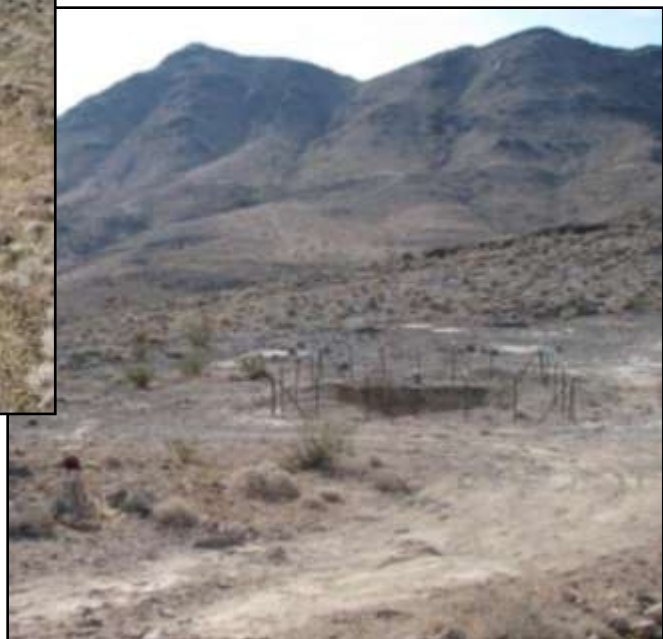
Fences Installed with Assistance from the California Conservation Corps, Mojave National Park, San Bernardino County, May 2008

In May 2008, National Park Service staff assisted by a California Conservation Corps crew and with funding from the AMLU installed fences around 17 hazardous abandoned mine features within the Mojave National Park.

The sites are located along frequently used trails, and tire tracks can be observed on the waste dumps and trails leading to several shafts.

"Thanks for funding our projects. To this point, we have completed the chain link fence around the trench and eight associated features. We also installed the footing for a bat cupola on the main shaft. At [another site], we installed six barbed wire fences and rebuilt an additional one. We also installed a fence around one shaft that is being used by barn owls and fenced a decline. More work to follow as this saved other project funds. Again, many thanks for the help."

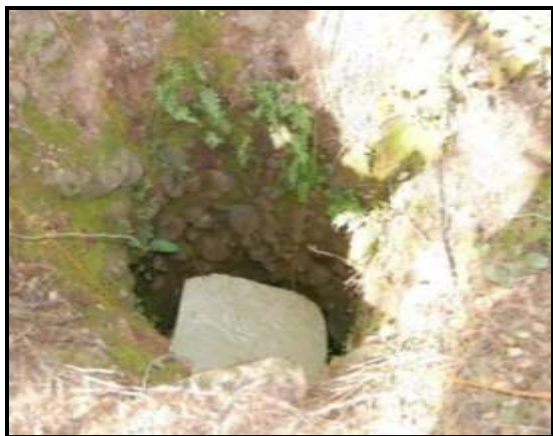
**INSERTING A
"FALSE BOTTOM"**

In March 2008, the AMLU, California State Parks, and U.S. Bureau of Reclamation teamed up to seal an abandoned mine shaft exposed as a hazard after a dog fell in. On January 21, Dewie, a golden retriever, was with his owners on a popular trail in the foothill community of Auburn. While chasing a rock down an embankment in a wooded area, he vanished down a 35-foot-deep shaft, part of Gold Rush-era workings. Hours later, Auburn firefighters pulled Dewie to safety. Rangers quickly placed a fence around the shaft, and the AMLU contacted State Parks with the offer to install a permanent fix. Six weeks later, Dewie returned to stand atop the shaft after it was plugged with expandable polyurethane foam (PUF) more than strong enough to support the weight of Dewie and his owners.

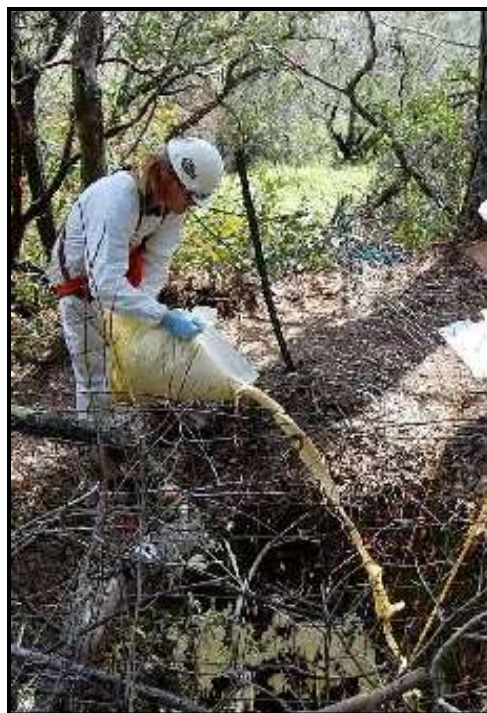
**POURING PUF INTO
THE SHAFT**

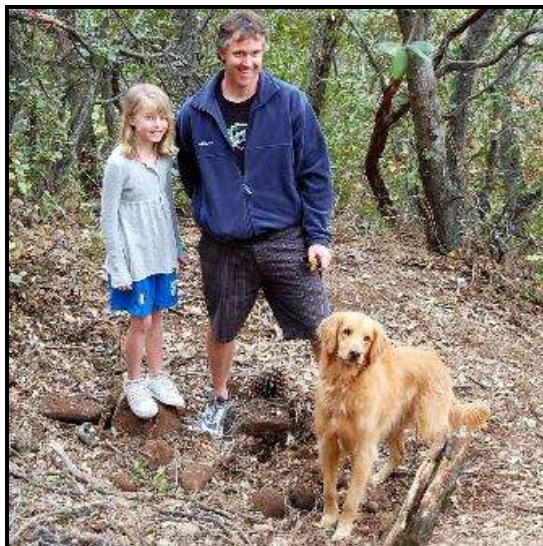
**SHAFT SITE (AFTER
THE CLOSURE)**

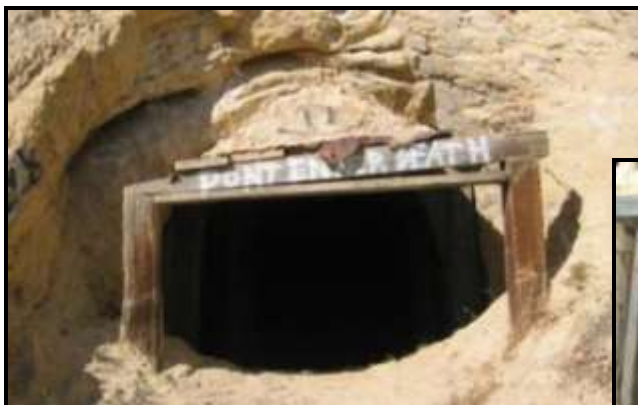
ADIT (BEFORE BAT GATE)

While the site is currently off-limits to the public, there is ample evidence in the form of graffiti and litter that it is visited frequently. Vandals had recently entered the site illegally and burned some of the 100-year-old wooden beams inside the entrance to one of the adits, potentially weakening the mine's supports. One mine had been used as a methamphetamine lab for a few days, until Park rangers discovered and stopped the operation. The bat gate also protects bats, including pallid and Townsend's big-eared bats, which have been found inside the abandoned mine and can hibernate or set up maternity colonies now that the human disturbance has been removed.

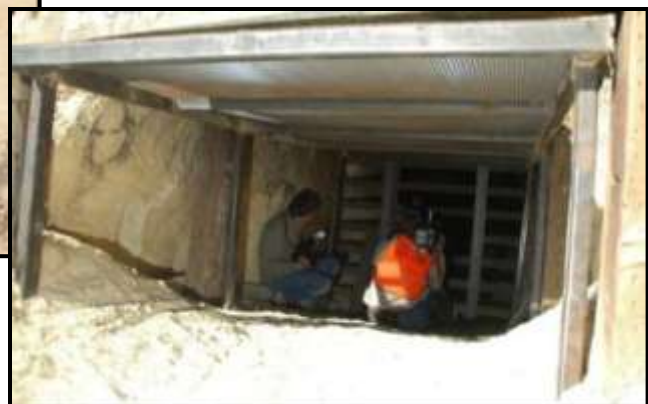
ADIT (AFTER GATE INSTALLED)

In January 2008, the AMLU and California Department of Parks and Recreation (State Parks) teamed up to protect public safety by installing several bat gates on hazardous abandoned mine openings at a historically significant site that was once California's largest coal mining center. The agencies invited the media to view the closure and to highlight the site's historical value and the AMLU's **"Stay Out – Stay Alive"** message.
